Condition Assessment
and
Reserve Fund Plan
2013

Crossings

On the Potomac

Hedgesville, West Virginia

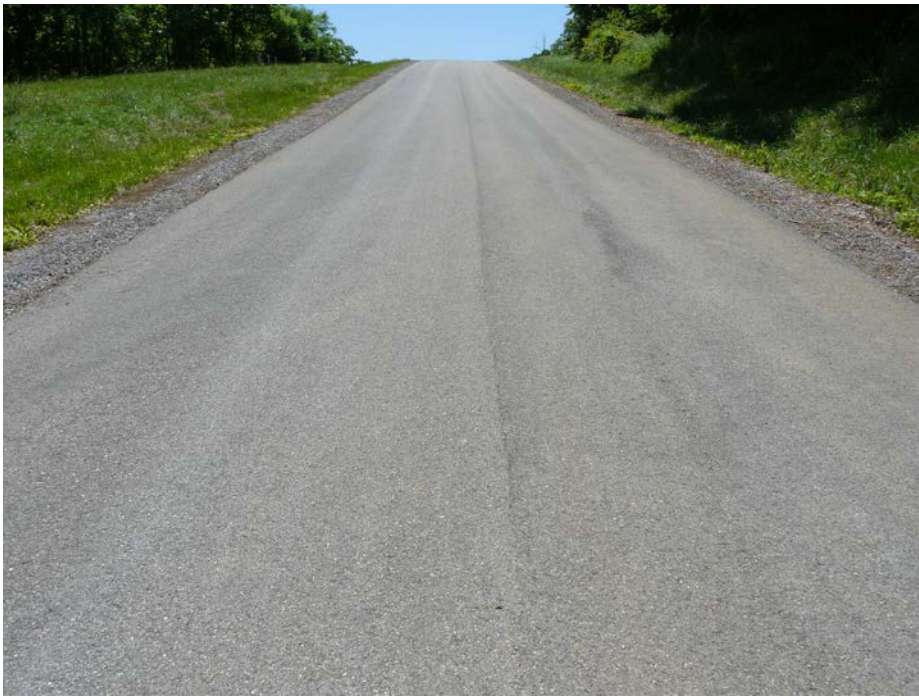
PHOTO #1
The P.O.A. asphalt roads throughout the community are in very good condition for their age. It appears that the original contractor established a proper sub-base prior to paving. Eventual restoration will be required and has been scheduled.

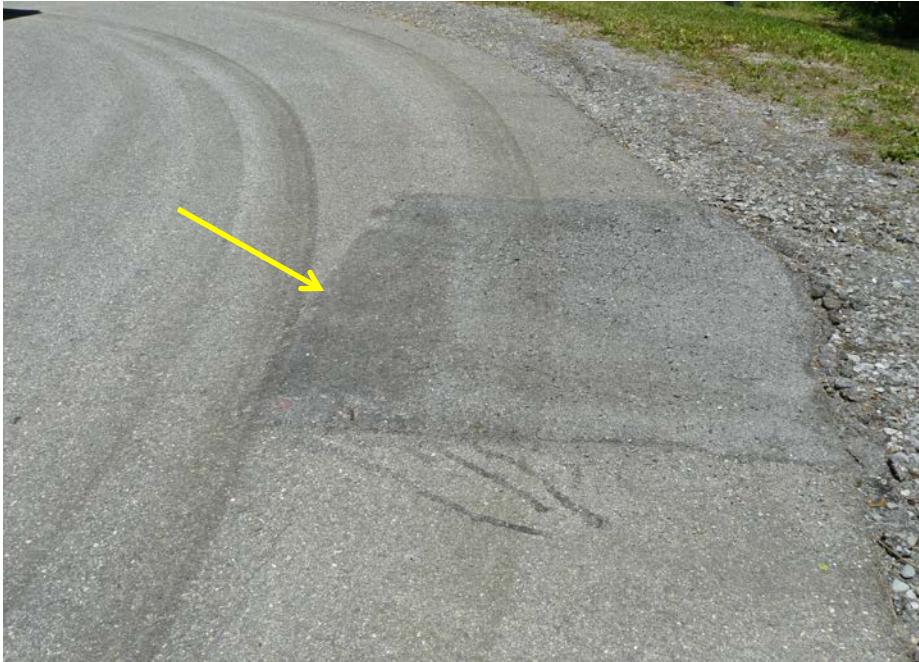
PHOTO #2
This is an example of a past full-depth repair. Any alligator or deflected pavement in the future will require full-depth repair. This should be accomplished during pavement maintenance projects, and prior to the asphalt restoration project.

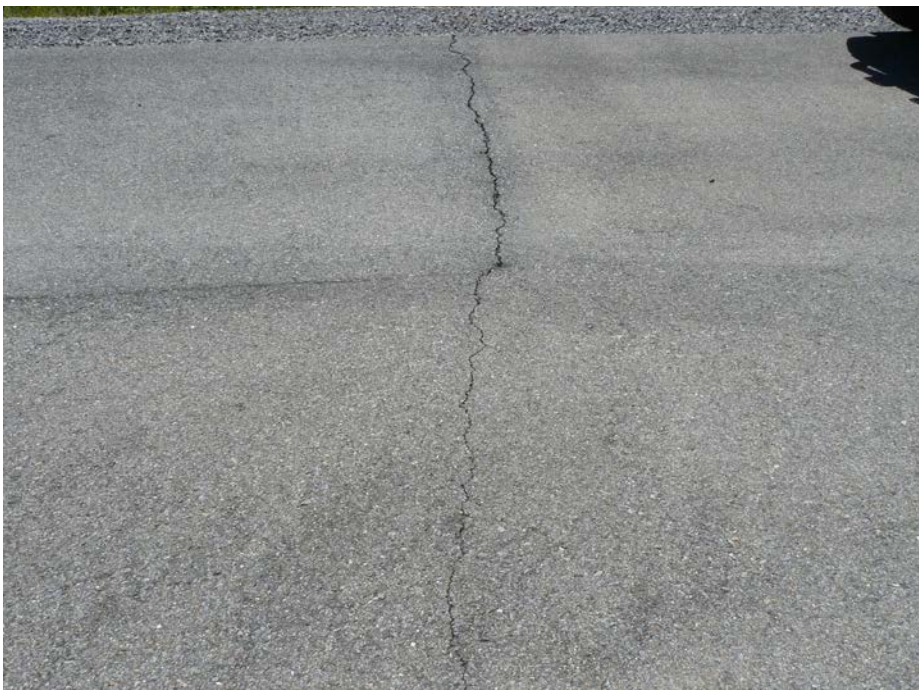
PHOTO #3
This is an example of transverse cracking. Longitudinal and transverse cracking should be filled during pavement maintenance projects, scheduled every five years. Some crack filling was recently completed.

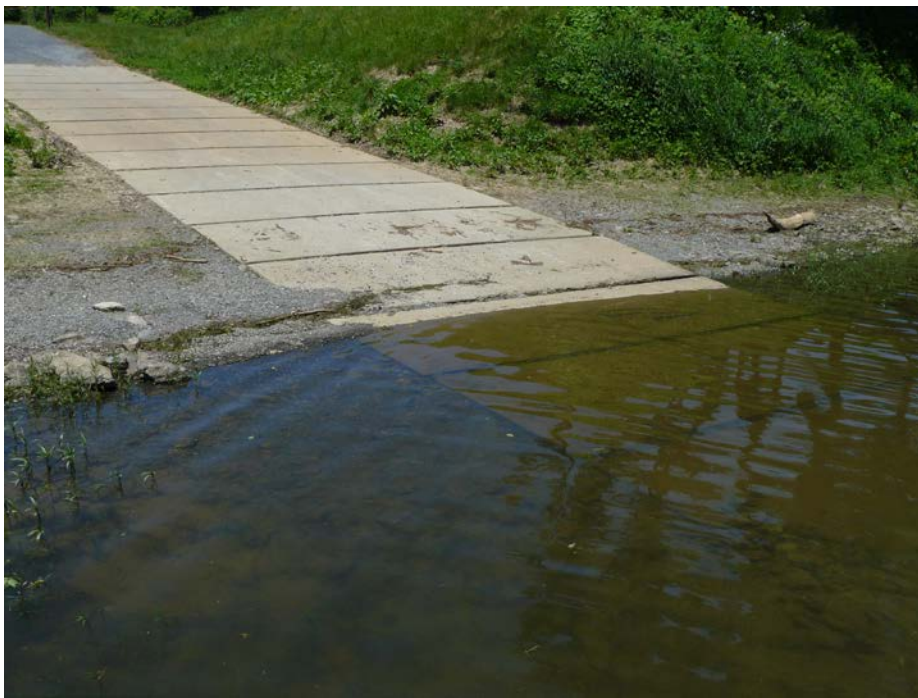
PHOTO #4

The concrete boat ramp is in good condition. This ramp was properly constructed in individual sections. This construction helps to prevent major cracking in the future, which would require the entire ramp to be replaced at one time.

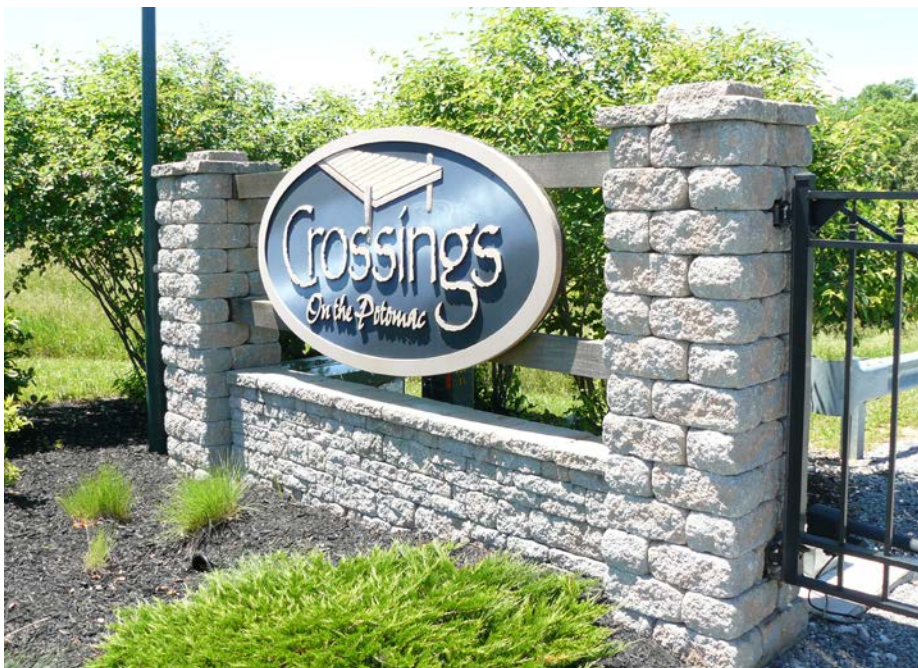
PHOTO #5

The modular block entrance monuments are in good condition. No deficiencies were observed on any of the monuments or the access key islands.

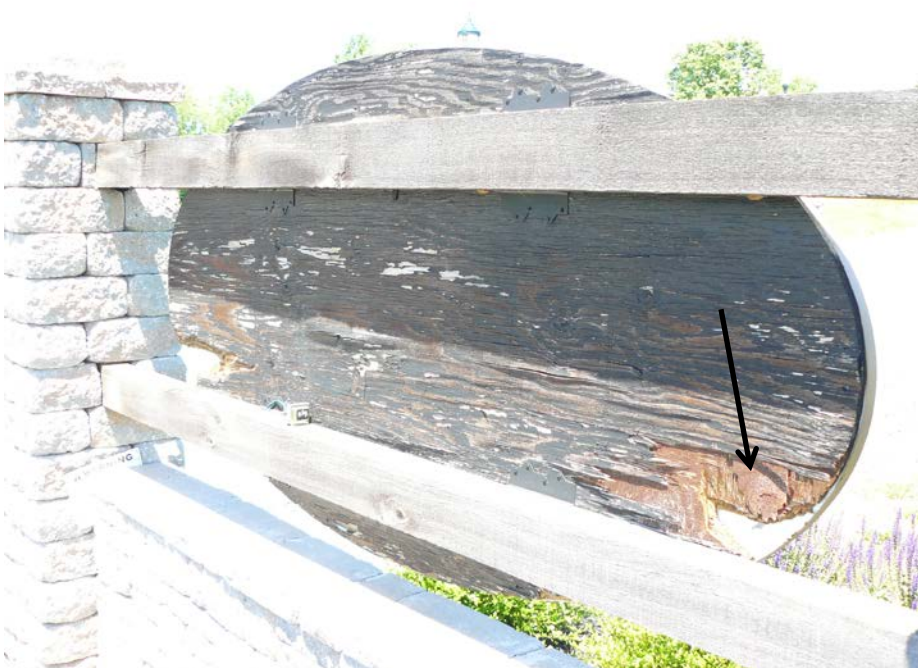
PHOTO #6

We understand that the damage found on the rear of the Conococheague Lane entrance signs is caused by deer. This backboard may require replacement earlier than we have the sign scheduled for replacement, which should be completed under Operations.

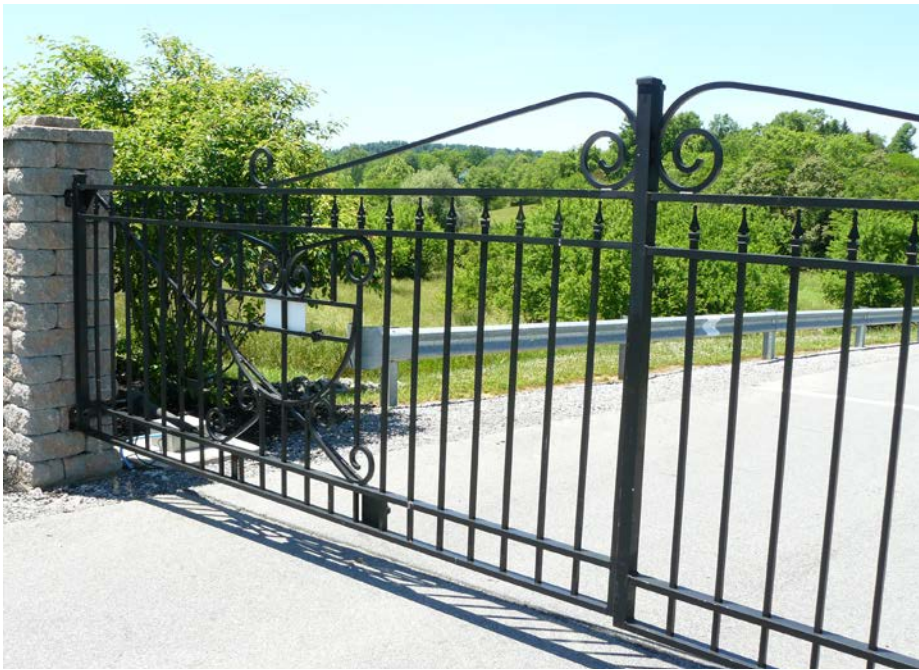
PHOTO #7
The metal entrance gates range from fair to good condition. Some gates were misaligned and should be straightened.

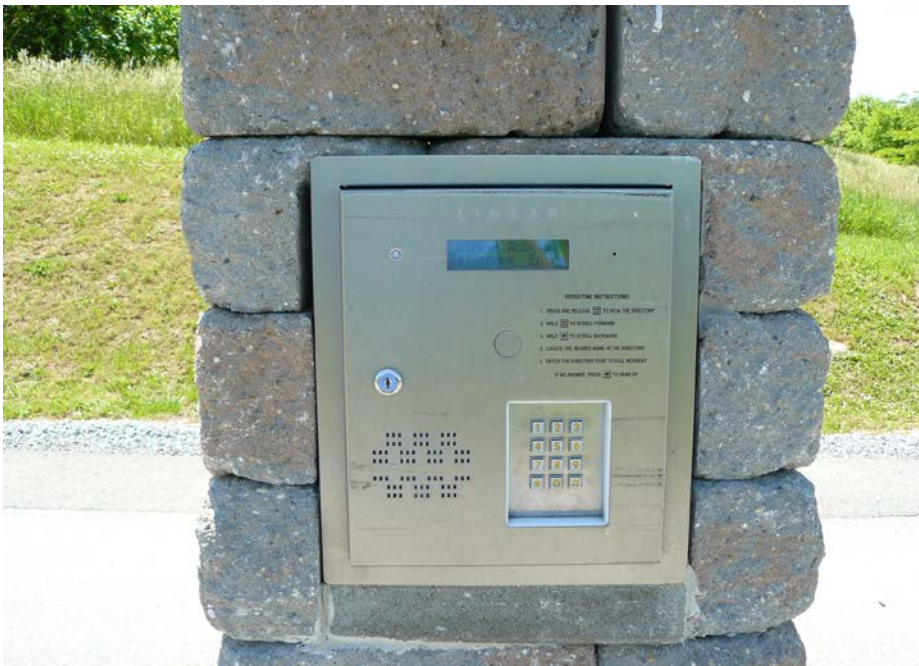
PHOTO #8
We understand that all of the electronics, other than the keypads were replaced on all four of the entrances circa 2011. All components appeared to be functioning properly during our condition assessment. Battery operation was not tested.

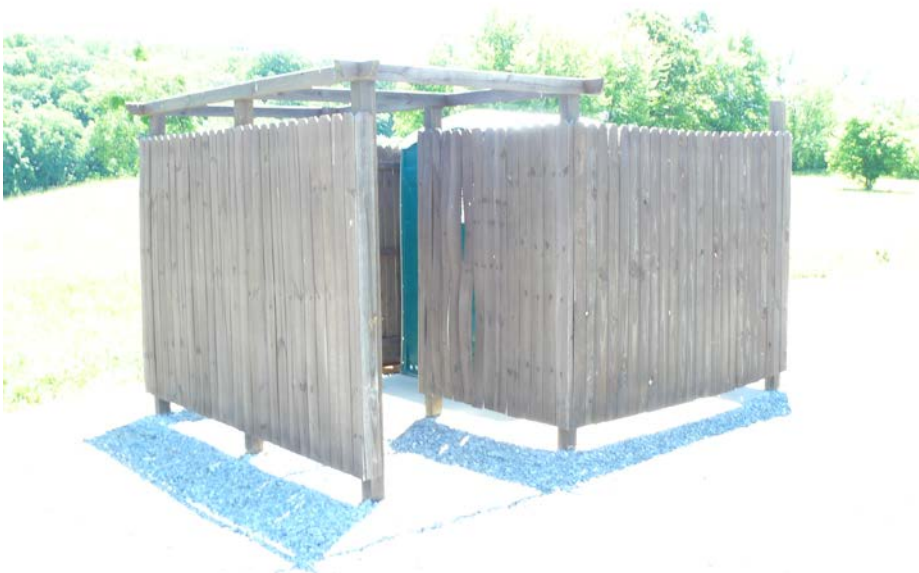
PHOTO #9
The wood privacy fencing installed around the portable toilets is in good condition. Maintenance, such as staining and repairing of loose boards should continue.

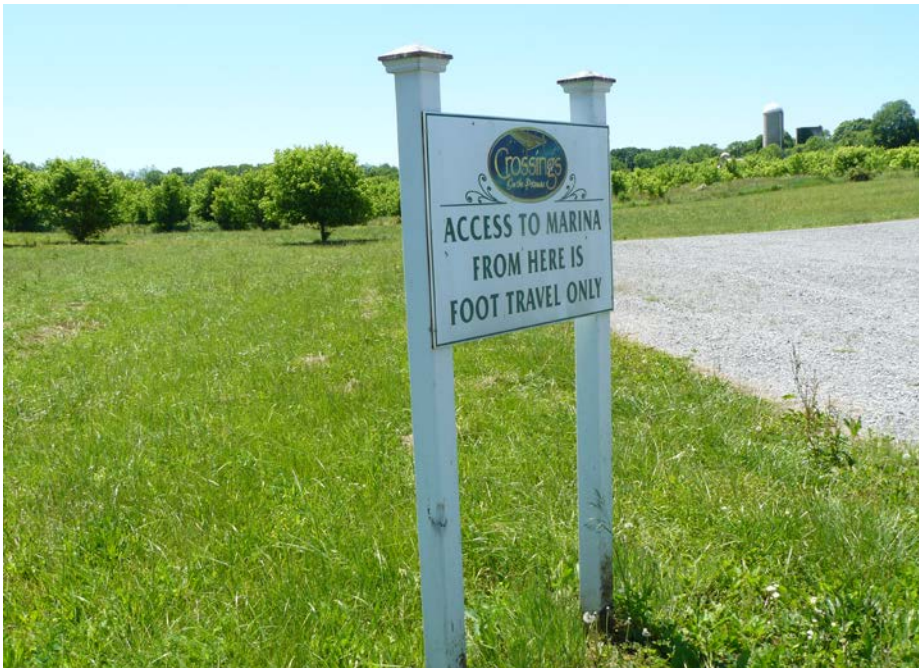
PHOTO #10
The wood signage installed throughout the community ranges from fair to good condition. Some signs and posts require repainting.

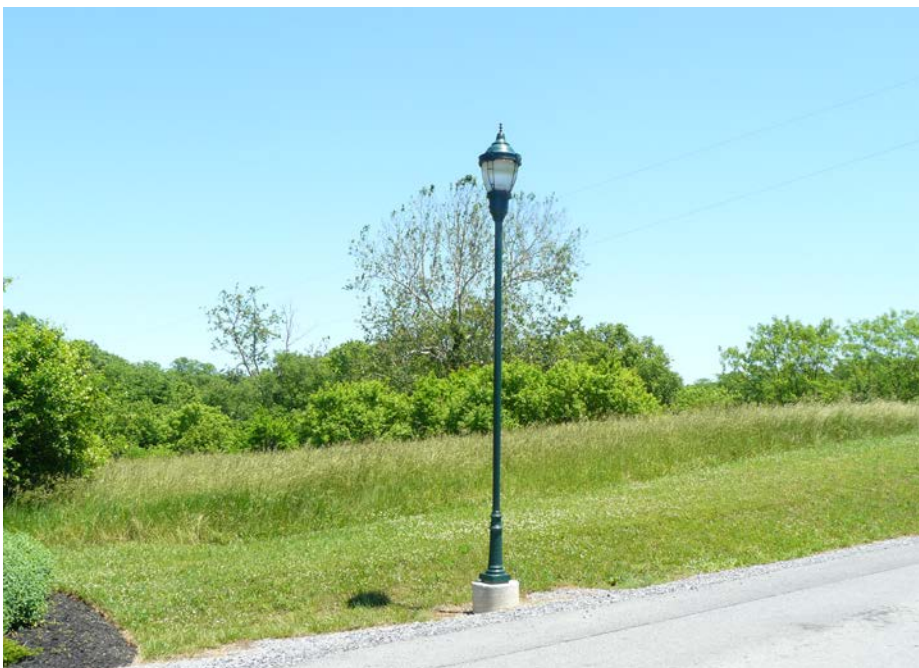
PHOTO #11
The P.O.A. street lights installed at each key access pad island are in good condition. We did not observe lighting after dark and no problems were reported.

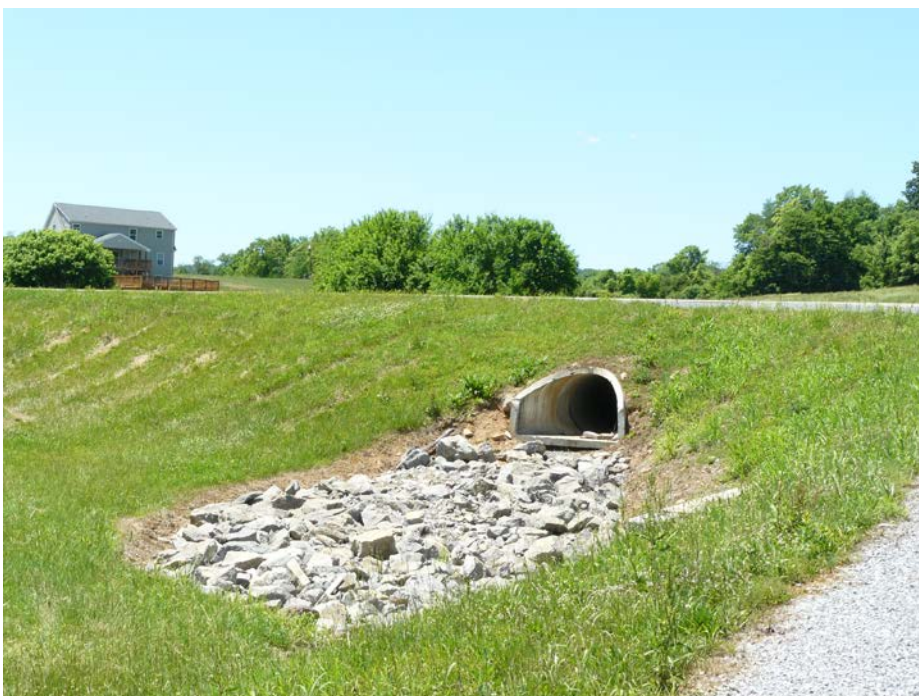
PHOTO #12
Culverts constructed of pre-cast concrete or galvanized corrugated steel are installed in various locations throughout the community to facilitate storm water drainage. Additionally, large areas of rip-rap were also installed to prevent erosion.

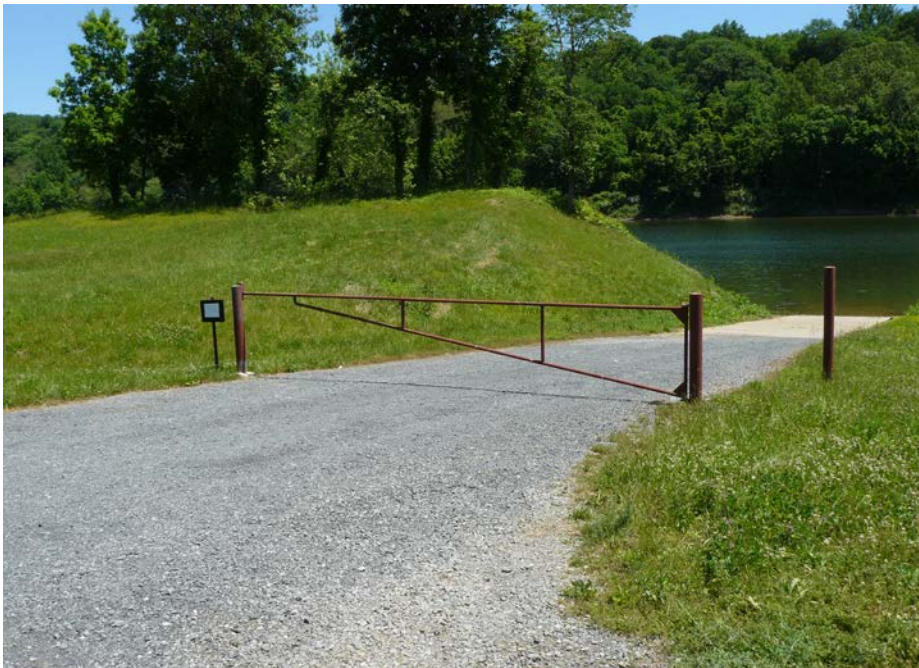
PHOTO #13

The locked metal gate at the top of the boat ramp is a great addition to prevent unauthorized access. The gate and posts will require future painting to prevent rusting.

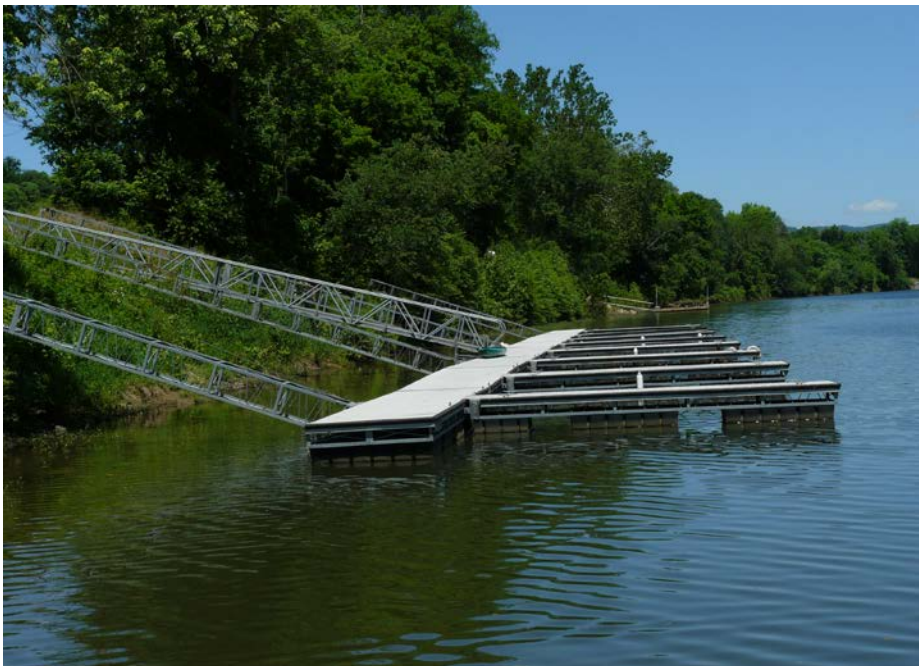
PHOTO #14

The floating docks are also in good condition. All of the plastic float drums appeared to be buoyant, all decking was in good condition, and the framing and outriggers were mostly rust free. No unusual wear was observed.

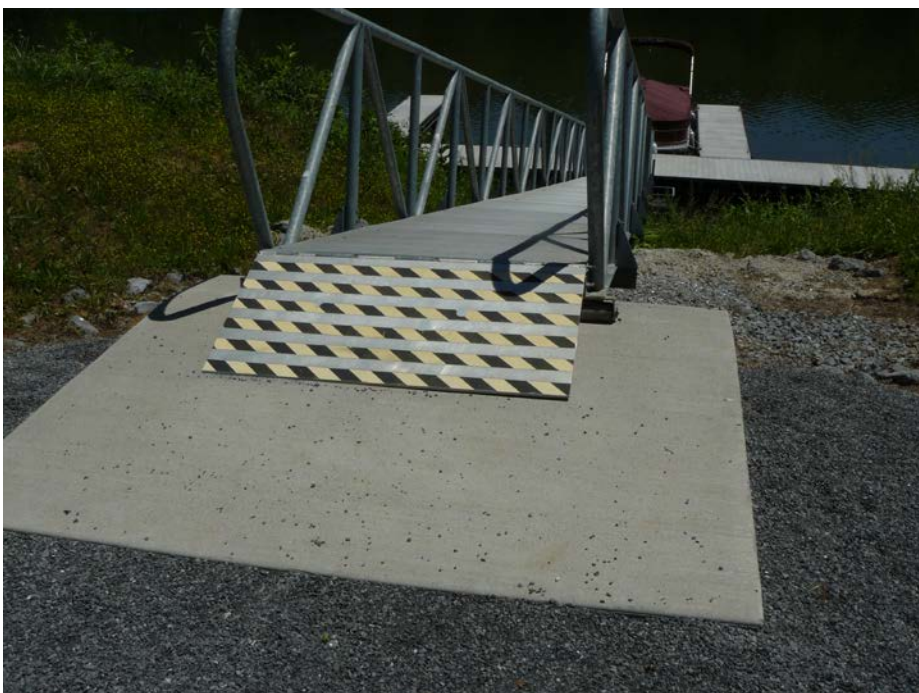
PHOTO #15

The concrete pads and the gangplanks were also in good condition, with no major deterioration observed.
